## Full-scale field testing: Opportunities and challenges through example case studies

**ABSTRACT:** Full-scale field testing is critical for benchmarking and validating geotechnical methods, hypotheses and solutions. Over the years, the Norwegian Geotechnical Institute (NGI) and Deltires have conducted full-scale field testing for various problems and geotechnical solutions including piles, suction bucket foundations, slopes, embankments, dikes, different soil investigation techniques and instrumentations. NGI has developed a set of six well-characterised geotest sites with various ground conditions specifically for field testing (i.e. clay, silt, sand, quick clay, permafrost and snow/avalanche). This paper presents the geotest sites and discusses the opportunities and challenges with full-scale field testing though our experiences. The experiences are exemplified with 2 case studies: a cut slope in cold climate in Norway and a dike failure in the Netherlands. The case studies show that full-scale field modelling can provide unique opportunities to investigate geotechnical problems in realistic operational environment without requirement for sample preparation and scaling laws. H

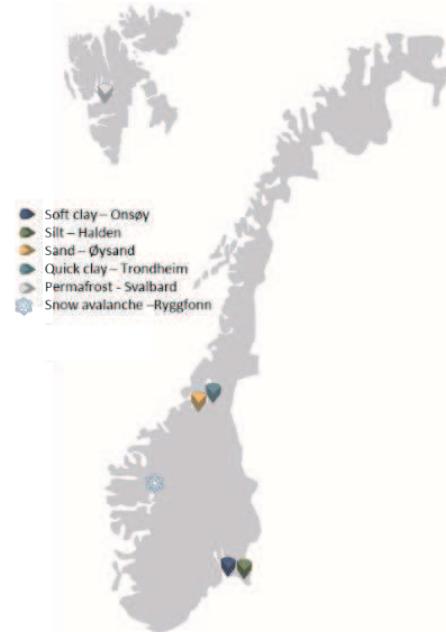
Fig. 1. Location of the geotest sites in Norway/Svalbard map.

The geotest sites research infrastructure is a unique research facility in Norway, established specially for field testing and modelling (Fig.1). These test sites are well-characterised and instrumented with basic monitoring system for pore pressure and temperature to provide field "laboratories" for the testing. The sites cover the different soil conditions and various geotechnical problems can be explored.

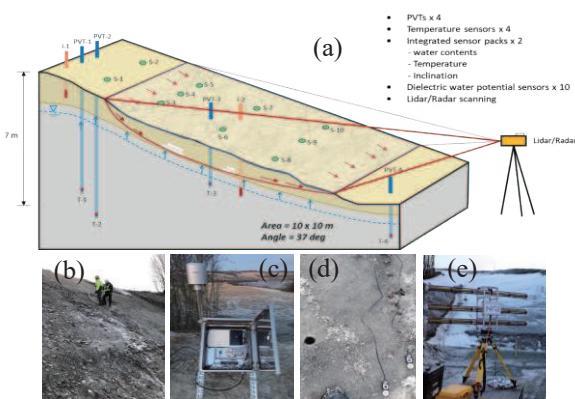
Fig. 2. Test slope at Øysand Trondheim Norway: (a) layout of sensor locations; (b) inclinometer installation on 37 degree man-made test slope; (c) data logger box at top of the slope; (d) MPS-6 sensors; (e) Lidar system.

investigation, laboratory tests, and numerical analysis specific for this study. A man-made cut slope was then generated and instrumented with a remote monitoring system to observe its behavior against the factors governing slope stability (Fig. 2). Monitoring was carried out between November 2019 and March 2020. The soil conditions and monitored data were used to calibrate the coupled thermal-hydro-mechanical numerical model in GeoStudio, see Shin et al. (2020) for details.

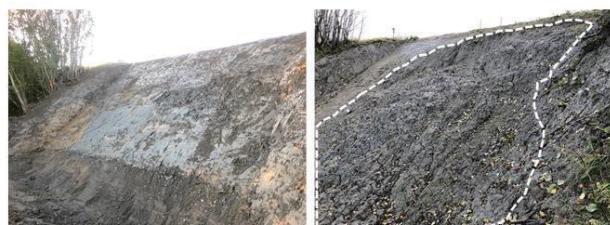
Fig. 3. Man-made slope in Øysand site before (left, November 2019) and after failure (right, April 2020)

between -10 and +20 °C. The slope failed in April 2020 after a heavy precipitation event (Fig. 3) but it was not possible to recover key monitoring data due to malfunction of sensors damaged by the failure. Back-calculations showed that the most likely cause was heavy rainfall with intensity over 5 mm/hr which increased pore water pressure and decreased the matric suction (Fig. 4). This resulted in reduction of shear strength leading to failure.

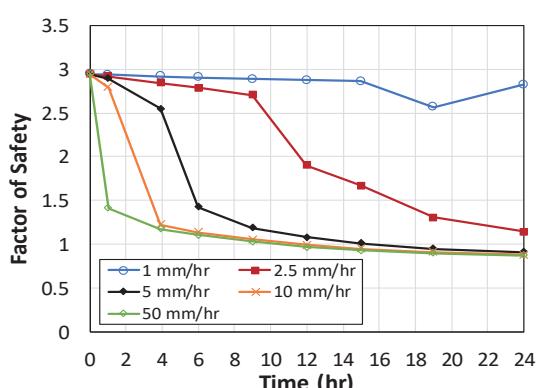
Fig. 4. Calculated factor of safety for the tested slope against different rainfall intensities.

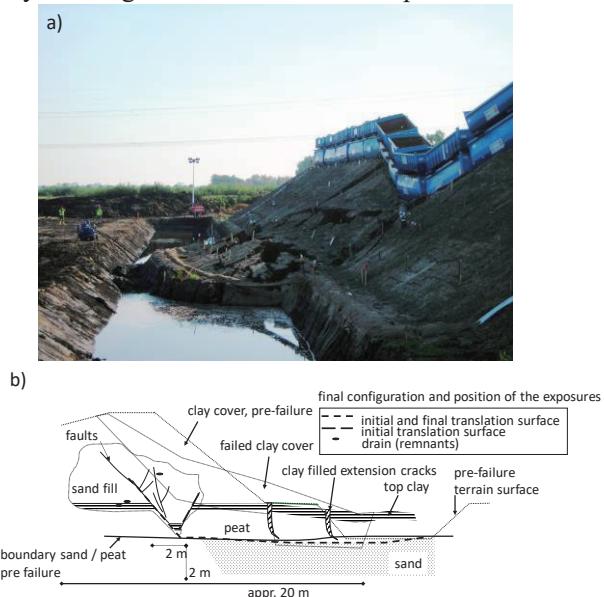
Fig. 5. a) Failure of the IJkdijk test embankment, the blue containers represent an additional loading mechanism b) deduced failure mechanism, from: Zwanenburg et al (2012)

The failure, Fig. 5a, was induced by excavating the peat and organic clay layer at the toe followed by infiltration of water in the sandy core. It should be noted that the excavation represents the ditch which is typically present at the inner toe of a dike. The containers, placed at the crest, could be filled remotely adding extra weight to the dike. Infiltration of the sandy core caused failure, thus loading by filling the containers was not needed.

After securing the situation, the embankment and sub soil were partly excavated to establish the failure mechanism (Fig. 5b). A numerical simulation of the test is presented by Den Haan & Feddema (2011). The failure mechanism is dominated by lateral displacement of the peat layer, with a horizontal sliding plane at the transition between the peat and Pleistocene sand. The results are consistent with other field trials including organic soil which showed that failure planes are typically found at the transition of soft organic layers and the stiffer sandy layers, (Muraro, 2019). Therefore, circular shaped sliding planes, which are typically used in limit equilibrium methods, should be applied with care in these conditions as they do not represent the shape of the failure plane correctly.
